Re: Cedar Chemical Corporation Consent Administrative Order

**WELL ASSESSMENT REPORT
CEDAR CHEMICAL COMPANY
WEST HELENA, ARKANSAS**

August 6, 2007

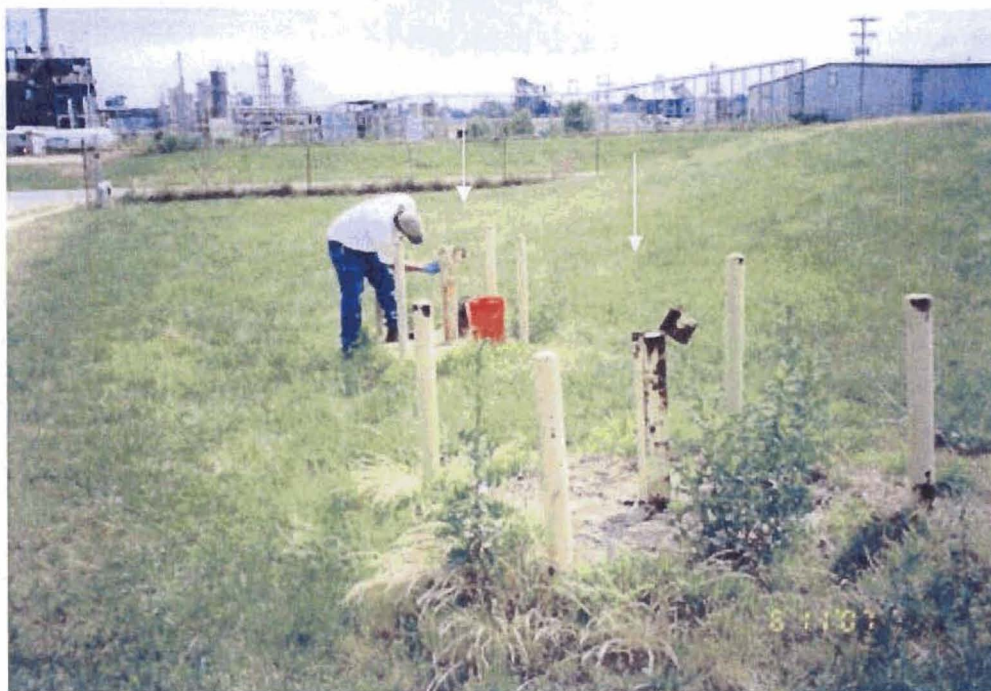
Photo 1: View of wells 1MW-1 (background) and 1MW-7 (foreground).

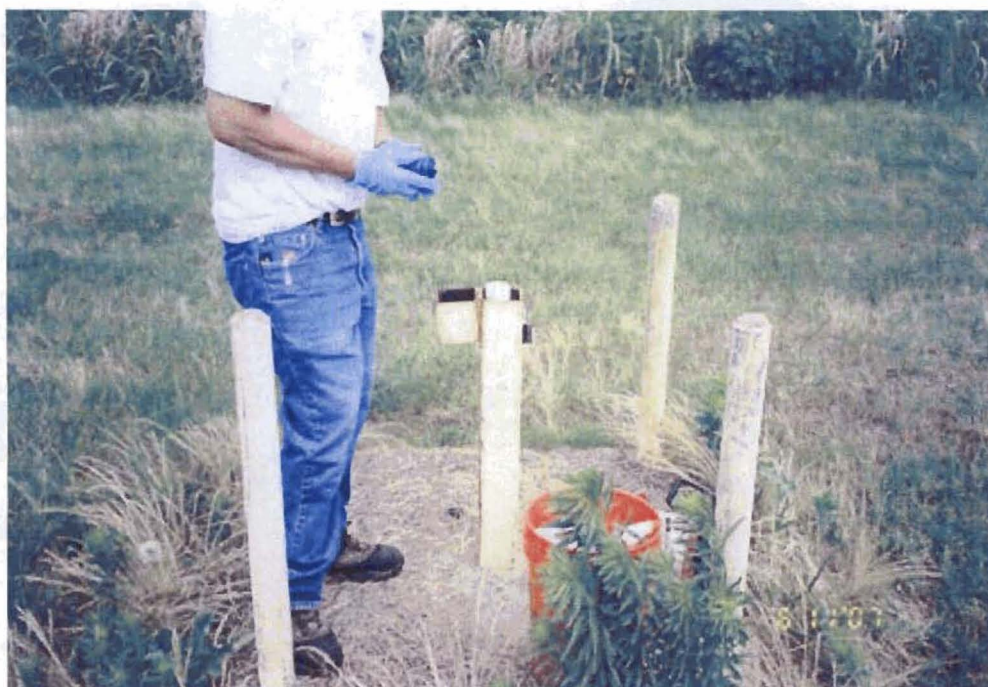
Photo 2: View of well 1MW-2.

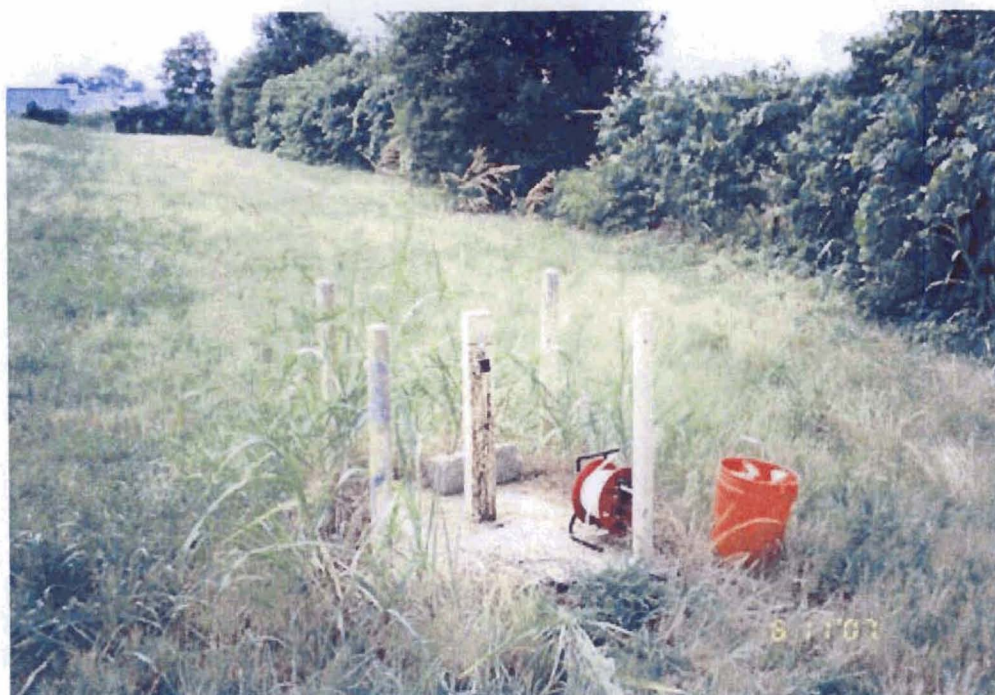
Photo 3: View of well 1MW-3.

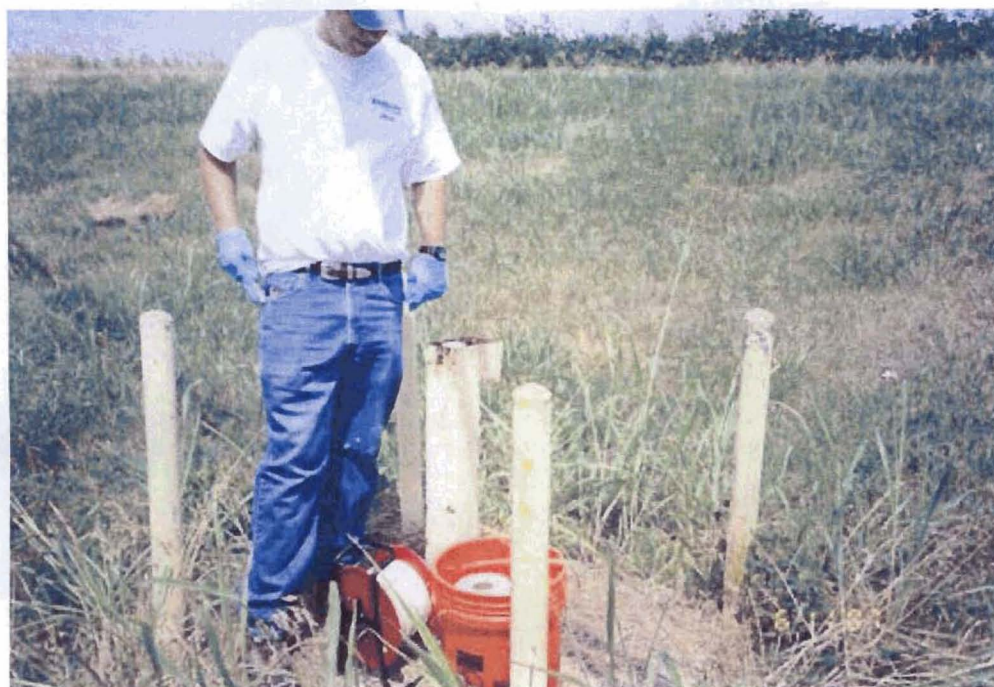
Photo 4: View of well 1MW-5.

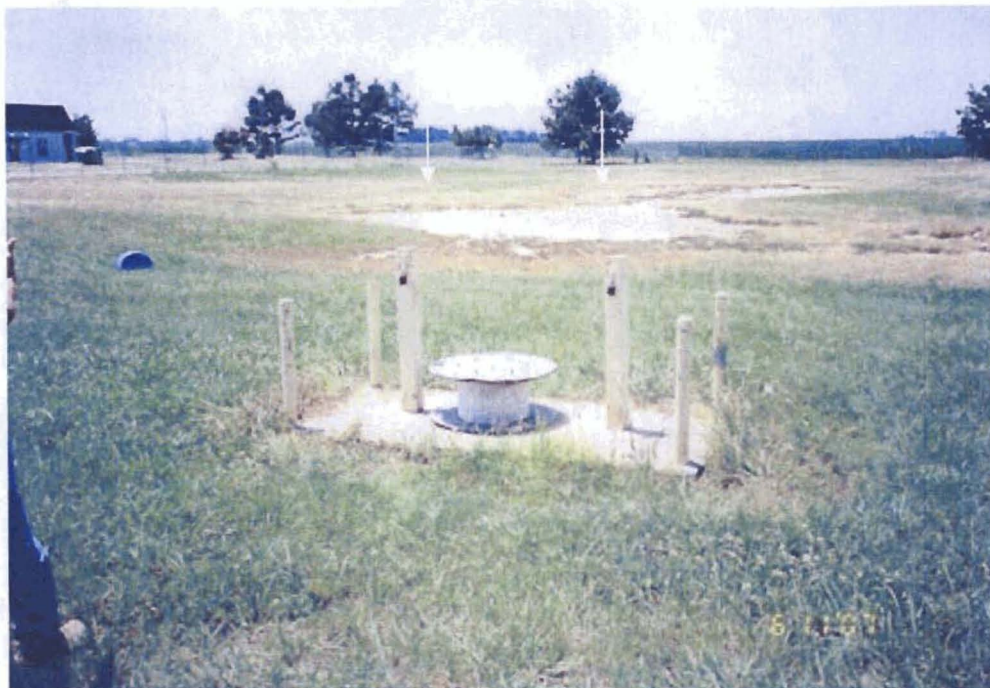
Photo 5: View of wells 2MW-4 (left) and 2MW-1 (right).

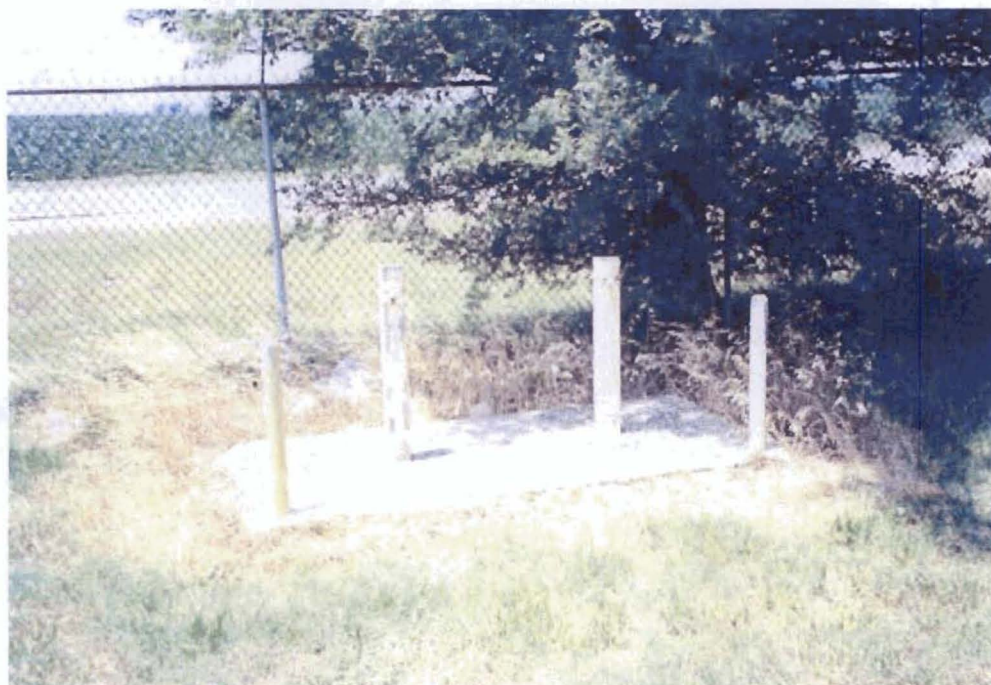
Photo 6: View of wells 2MW-5 (left) and 2MW-2 (right).

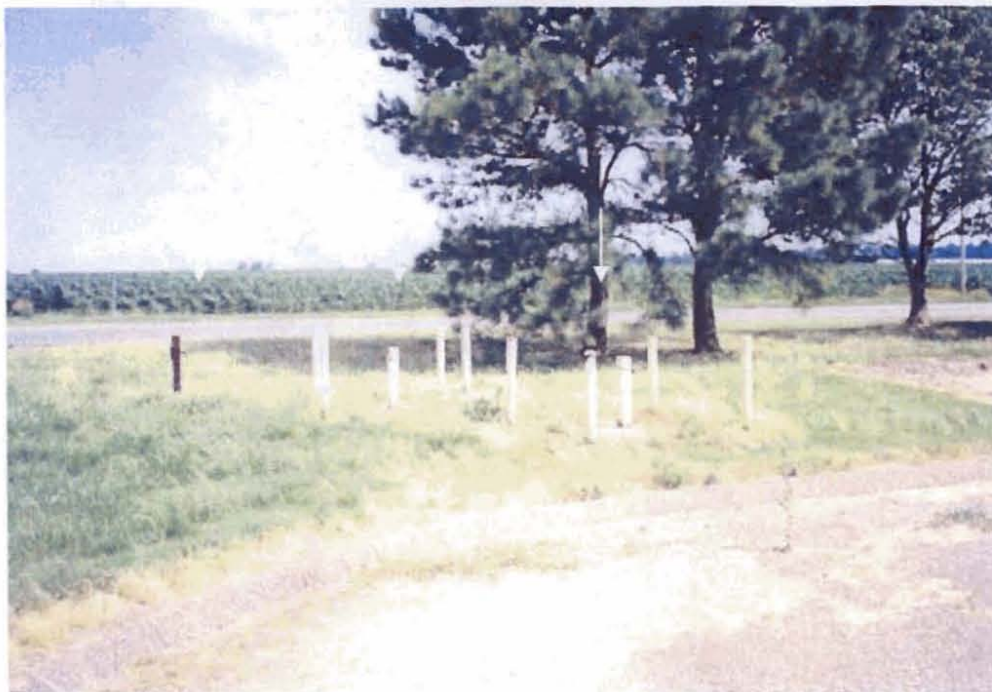
Photo 7: View an unidentified well (far left) and wells 2MW-6 (middle) and 2MW-7 (right).

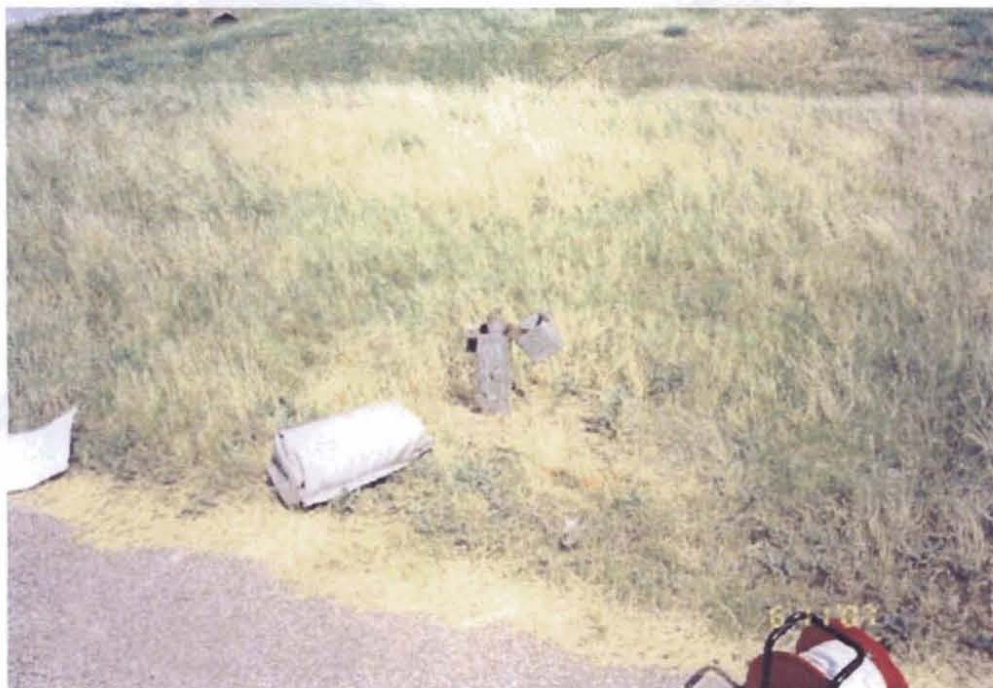
Photo 8: View of well EMW-1.

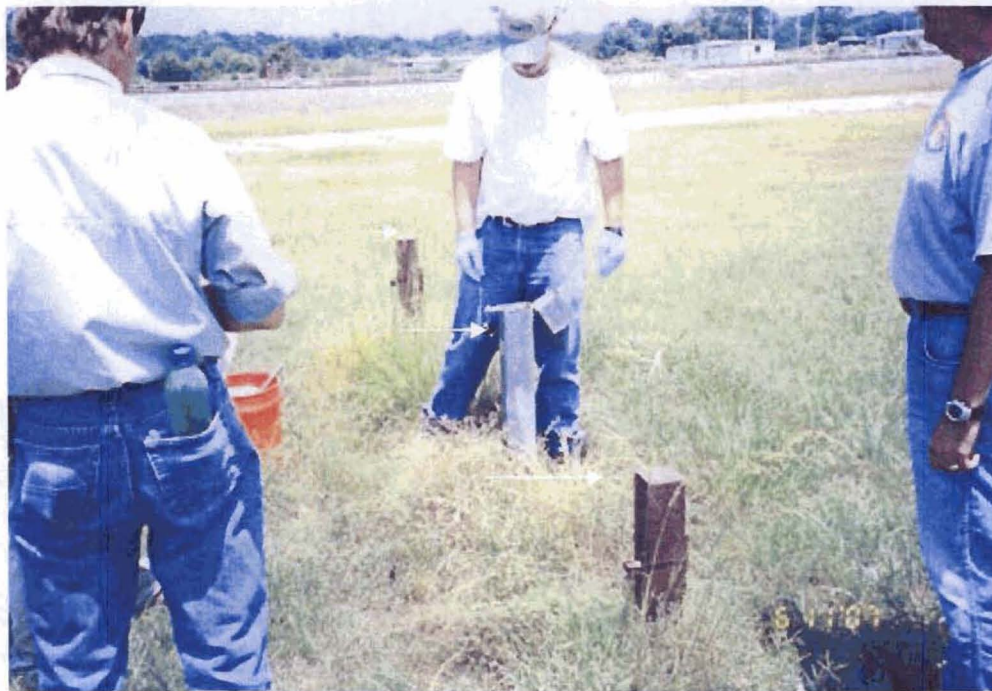
Photo 9: View of two unidentified wells (foreground and background) and well EMW-2 (middle).

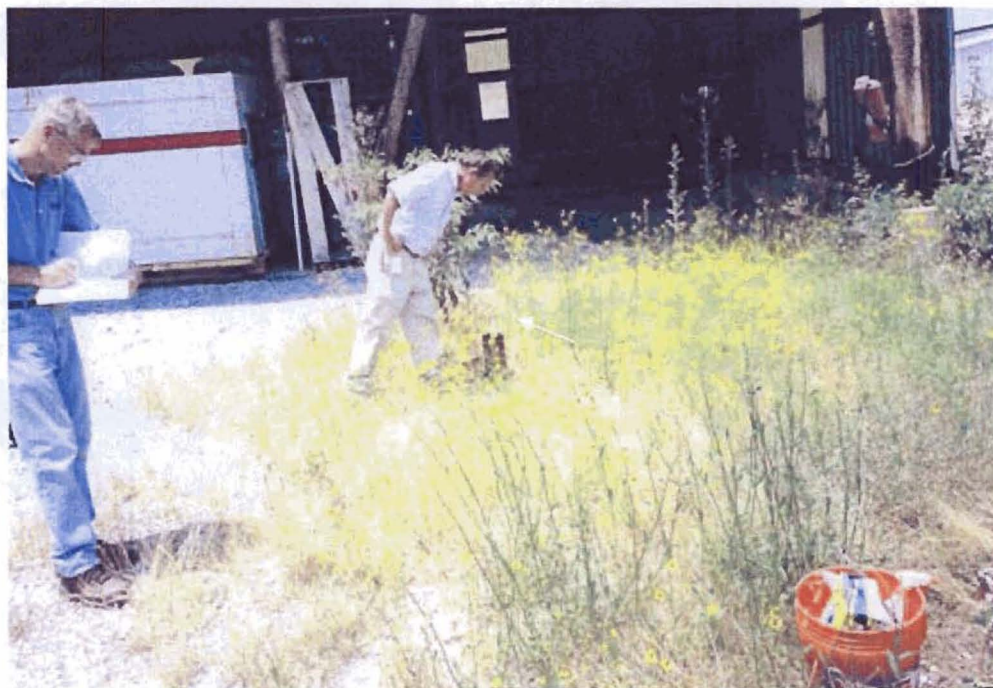
Photo 10: View of well EMW-3.

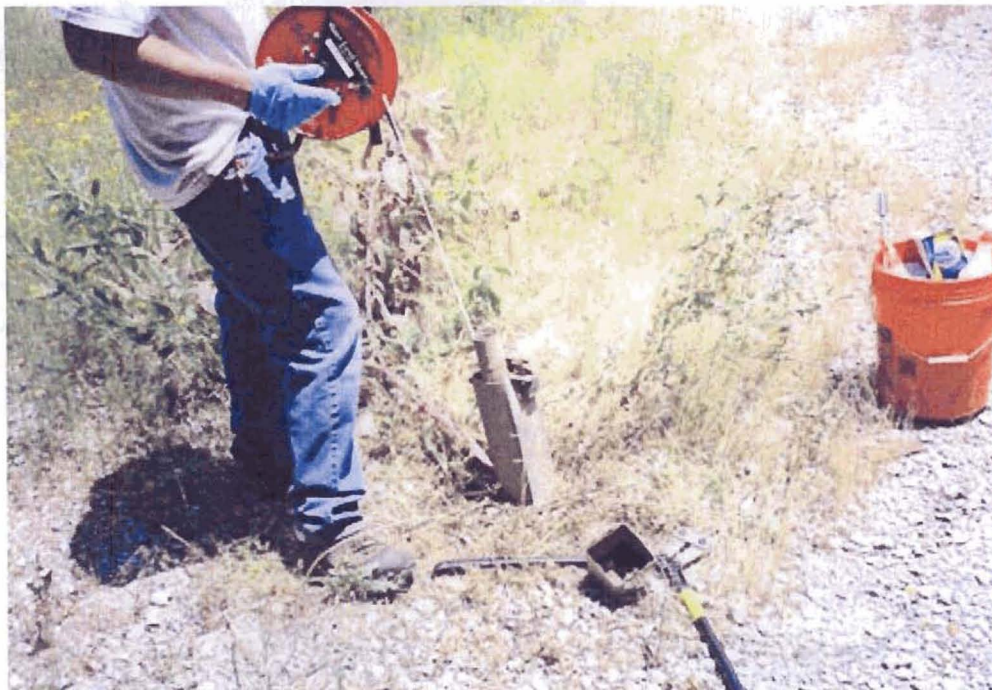
Photo 11: Close-up view well EMW-3.

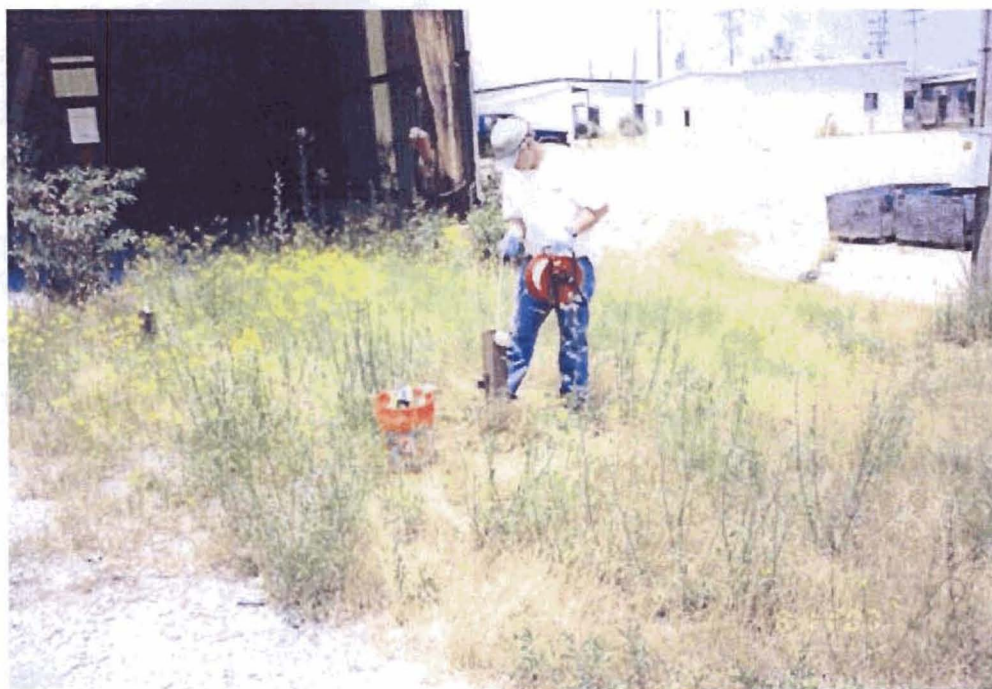
Photo 12: View of an unidentified well near EMW-3.

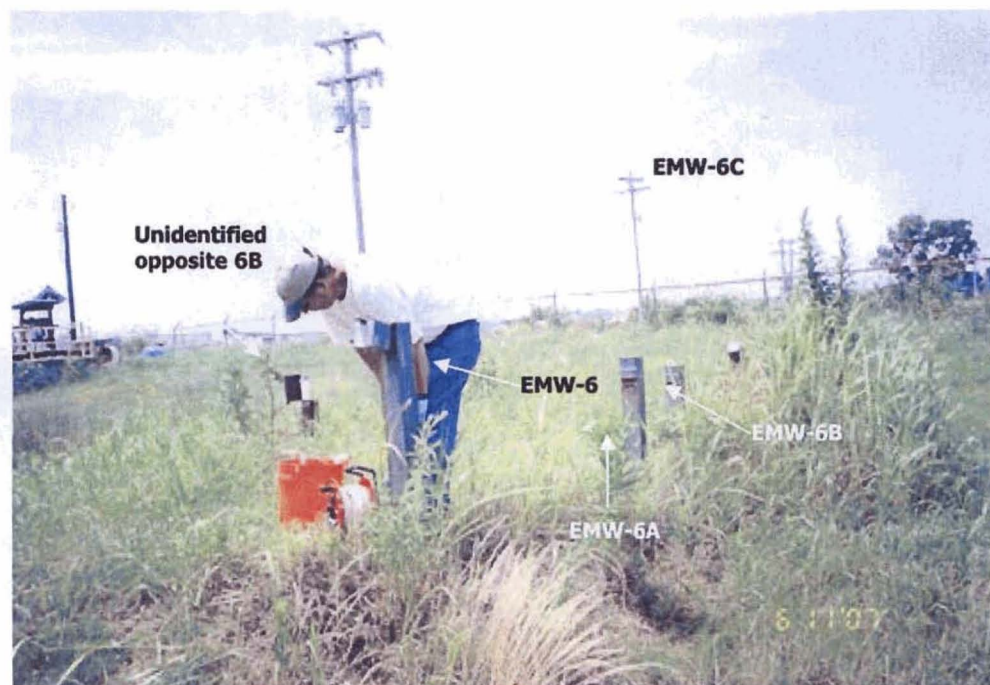
EMW-4B	51.62	37.18	UKN	UKN	UKN	1036	UKN	Good condition, rusted; well location is north of EMW-4
EMW-6	81.28	39.52	199.56	39.52	160.04	1146	UPPER	Needs new expander cap
EMW-6A	50.44	38.51	198.54	NA	NA	1149	UKN	Needs new expander cap
EMW-6B	30.77	15.25	198.09	15.25	182.84	1153	PERCHED	Needs new expander cap; SWE and DTW not previously used
EMW-6C	17.48	15.06	UKN	UKN	UKN	1158	UKN	Outer cap hinge broken; Needs new expander cap, Well not on map
EMW-7	45.01	37.84	198.47	37.84	160.63	TNA	UPPER	Blocked by pipe storage; no lock
UKN	47.18	39.55	UKN	UKN	UKN	1240	UKN	Lock cut; Not numbered; Dirt on bottom of probe; well location is NE of Unit 5 at RR spur
UKN	43.31	37.78	UKN	UKN	UKN	1314	UKN	Well location is opposite EMW-3
UKN	19.74	19.38	UKN	UKN	UKN	TNA	UKN	Well location is opposite EMW-3
UKN	NR	NR	UKN	UKN	UKN	TNA	UKN	Two wells adjacent to EMW-2; Not read
UKN	23.85	15.27	UKN	UKN	UKN	1200	UKN	Ok-rusty outer; Well location is opposite 6B

Photo 14: View wells EMW-6, EMW-6A, EMW-6B, EMW-6C, and an unidentified well.

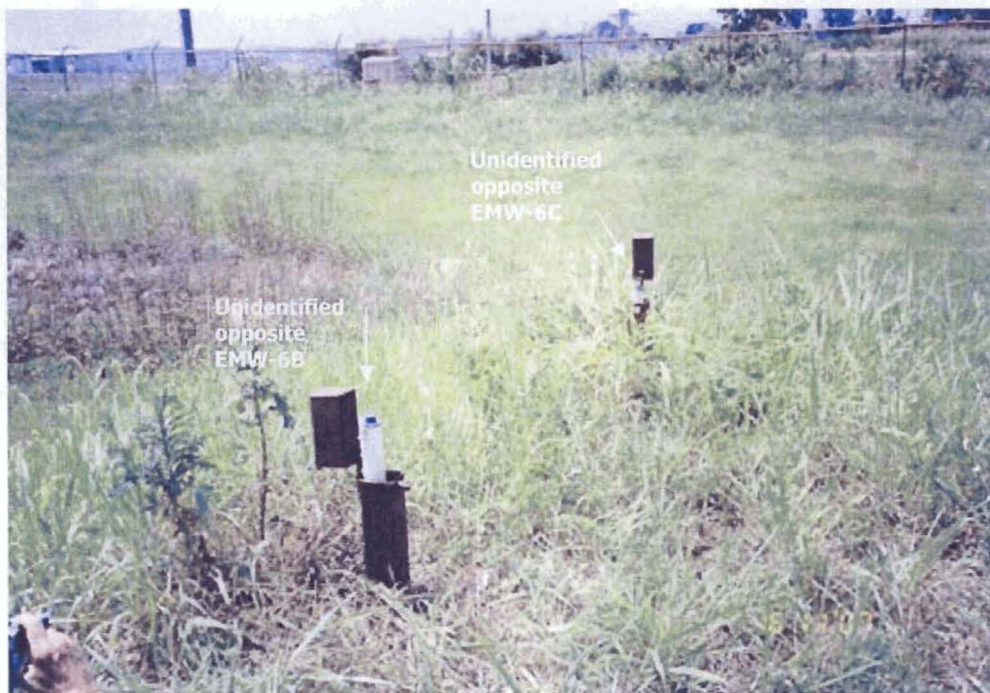
Photo 15: View of an unidentified well opposite EMW-6B and one opposite EMW-6C.

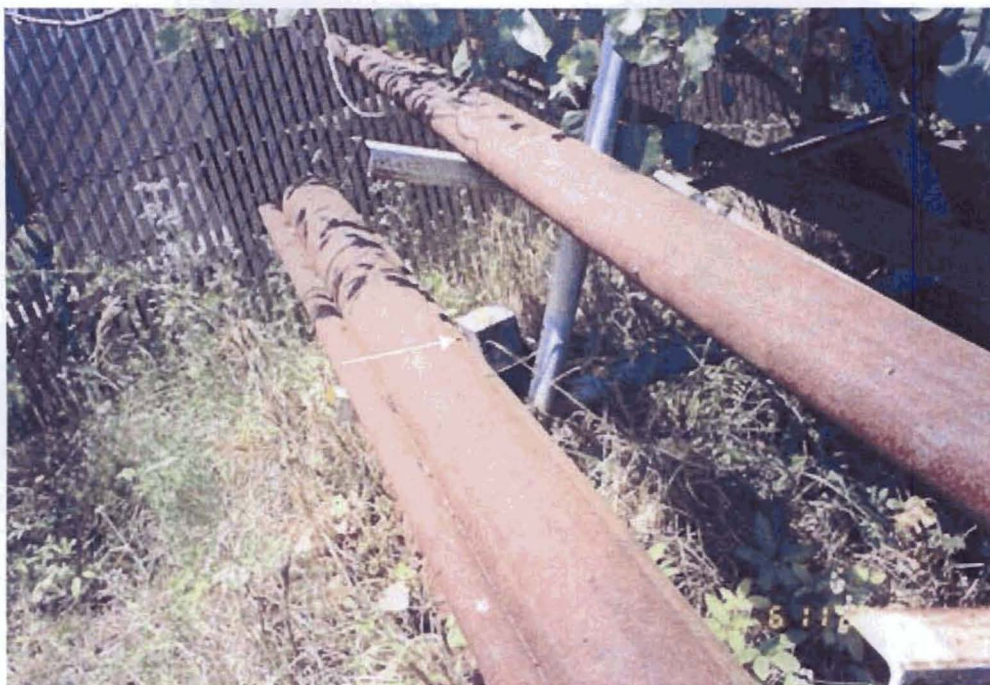
Photo 16: View of well EMW-7.

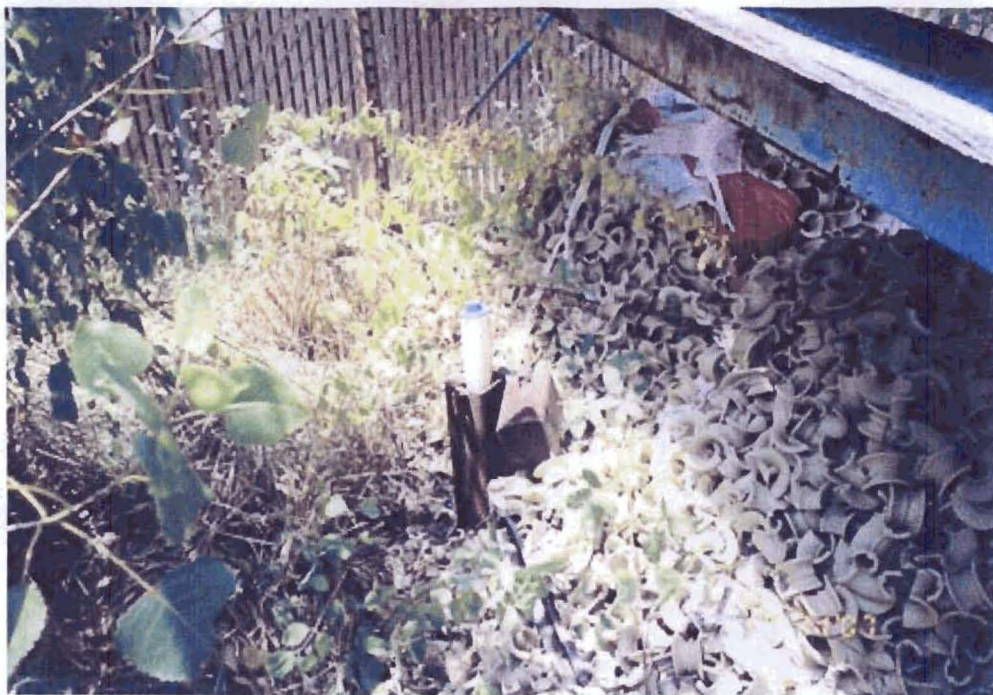
UKN	148.81	37.81	UKN	UKN	UKN	1203	UKN	Rusty outer, clay residue on tape-silt? Well location is opposite 6C
UKN	44.33	37.88	UKN	UKN	UKN	TNA	UKN	Good condition; well location is opposite EMW-7

Photo 17: View of unidentified well opposite EMW-7.

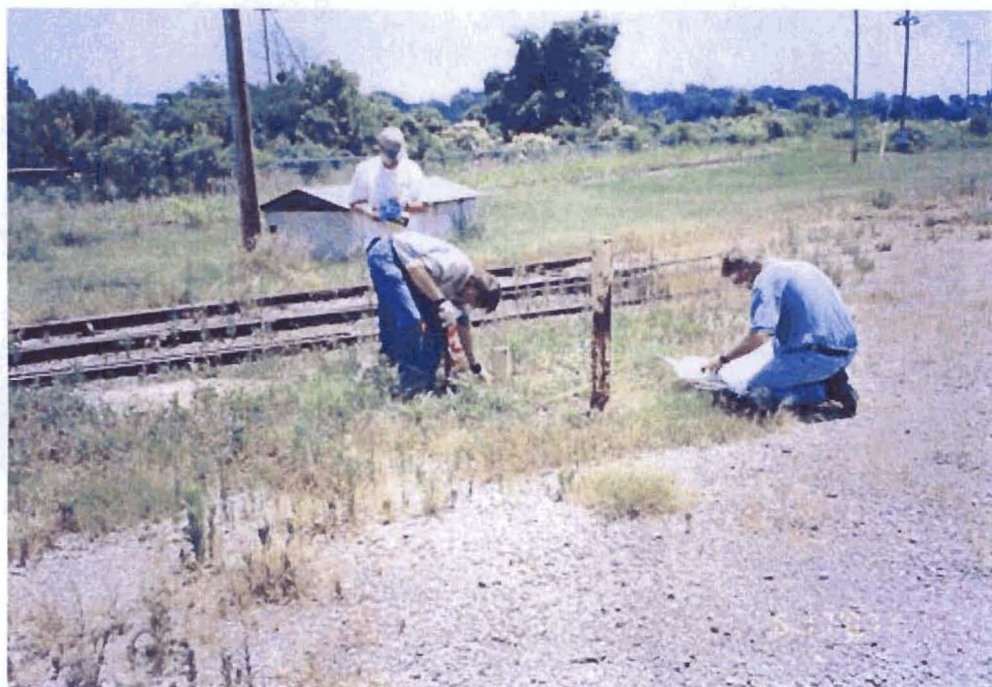
Photo 18: View of unidentified well northeast of Unit 5 at railroad spur.

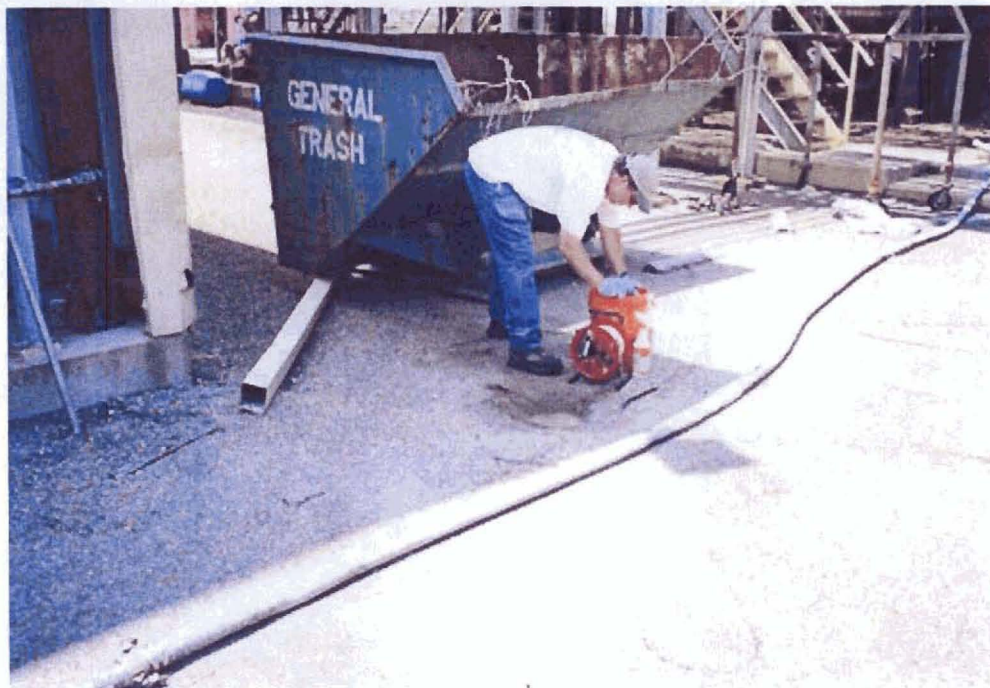
Photo 19: View of well 4MW-1.

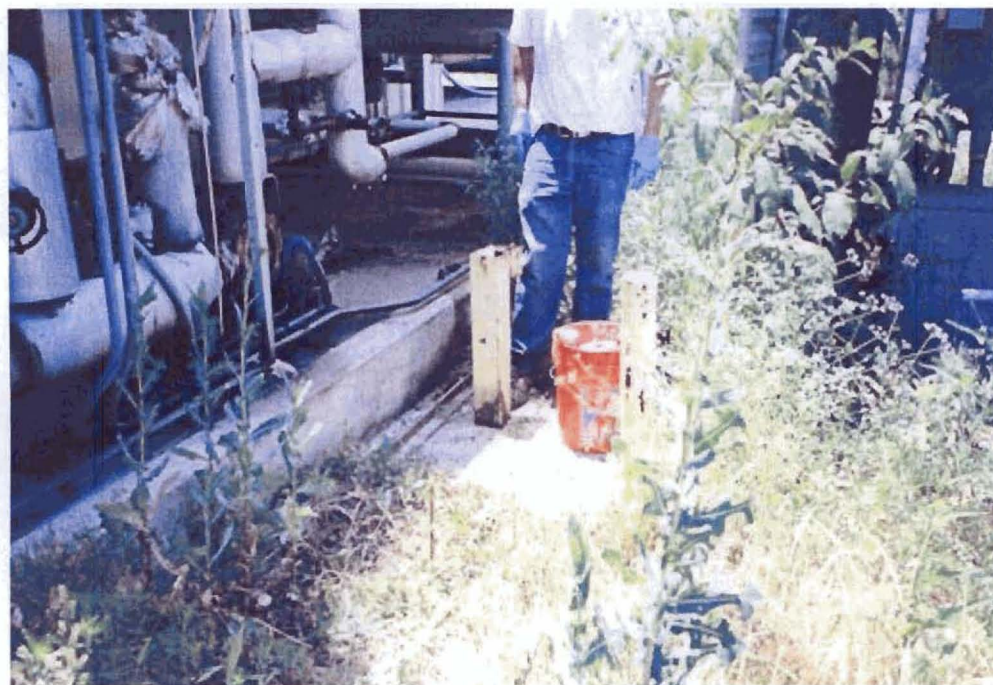
Photo 20: View of well 4MW-3.

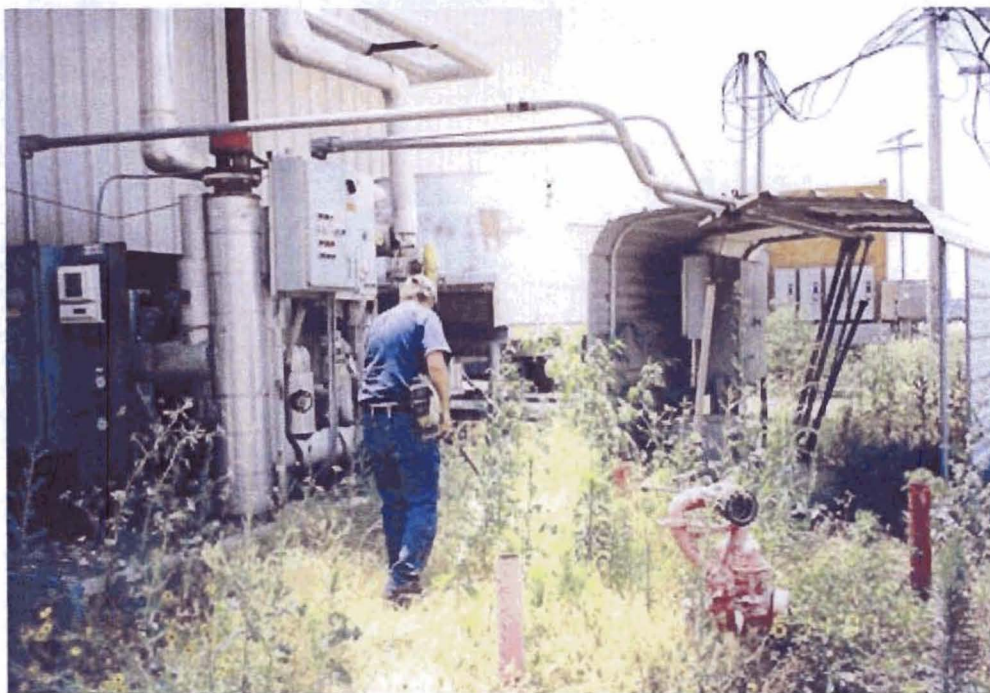
Photo 21: Clearing brush around well 4MW-3.

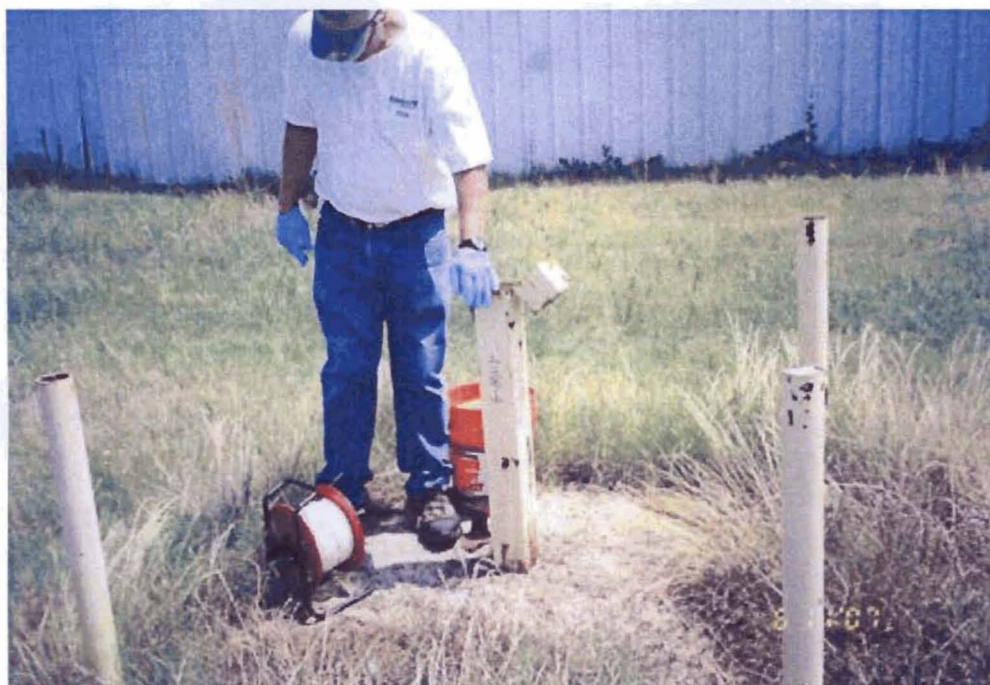
Photo 22: View of well 4MW-4.

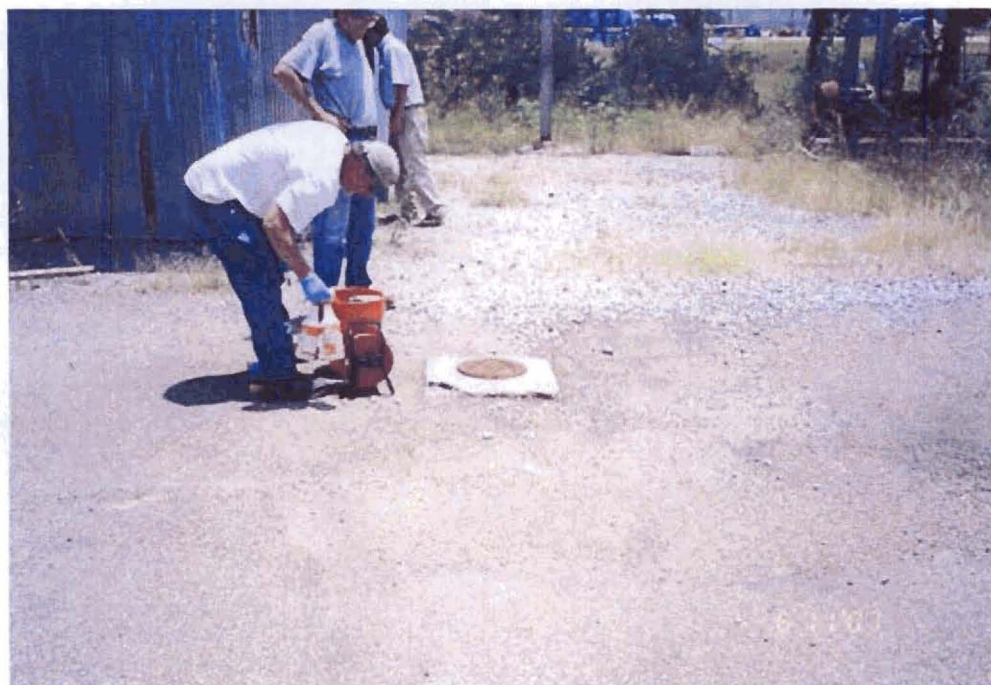
Photo 24: View of well 9MW-1.
